REQUEST FOR PROPOSALS

Ground Lease of State-Owned Property 1 Prison Road Jean, Nevada 89019

State of Nevada
Department of Corrections
Southern Nevada Correctional Center
Facility Condition Analysis

Site Number: 9994
STATE OF NEVADA PUBLIC WORKS DIVISION
FACILITY CONDITION ANALYSIS

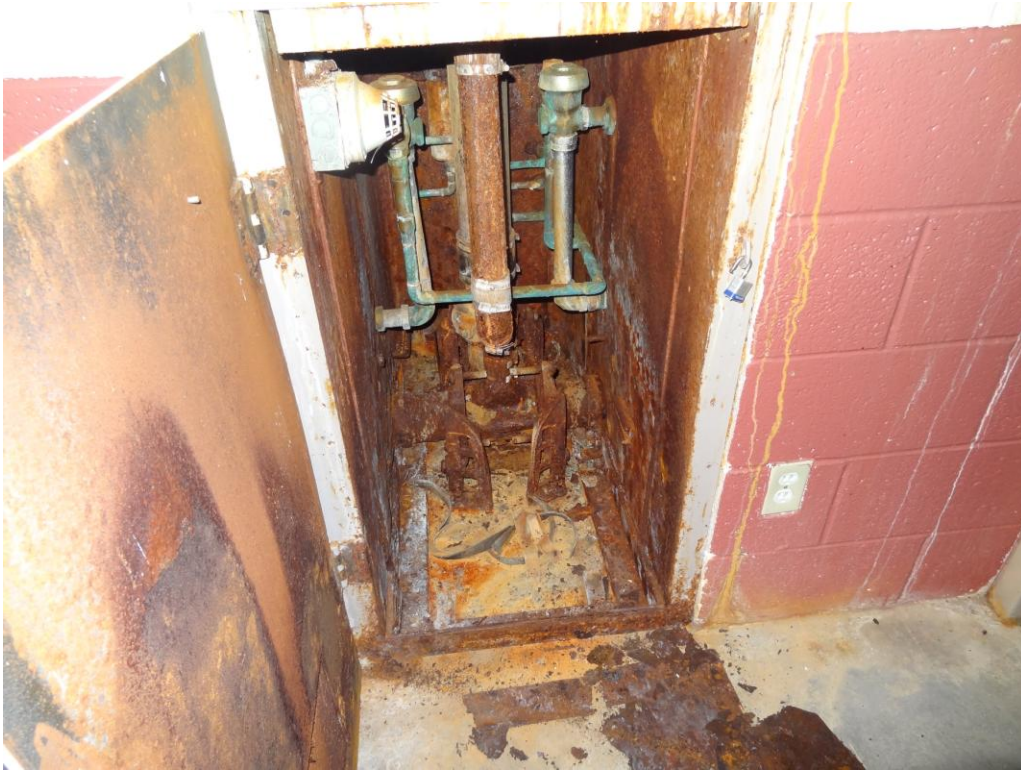
Housing Unit 5 - Building #0184
Description: Water damage from leaking pipes.

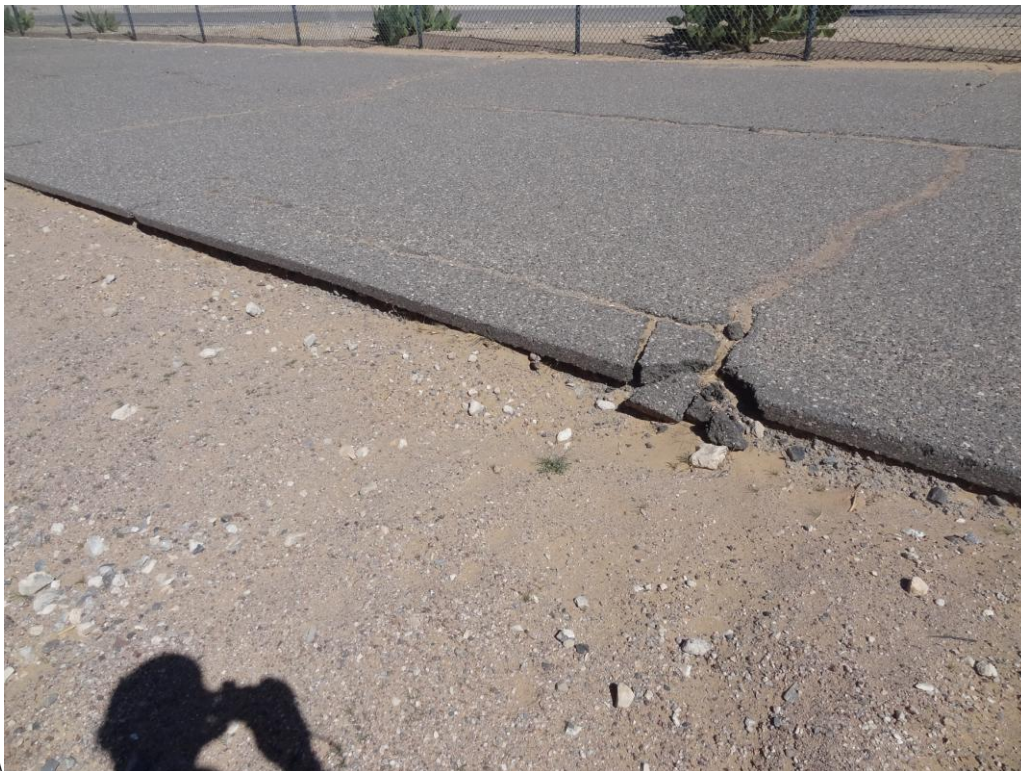
The access road and the parking area around the Maintenance and Auto Shop area is in poor condition and has significant alligating and large cracks. The paving has deteriorated to the point that it is no longer viable to re-seal. This project would provide for the removal and disposal of the existing A.C. paving and installation of 80,000 square feet of A.C. paving over a compacted sub-base. This estimate includes striping for parking areas and safety zones and excludes the main public / employee parking area.

Southern Nevada Correctional Center Site - Site #9994
Description: AC paving in need of replacement.

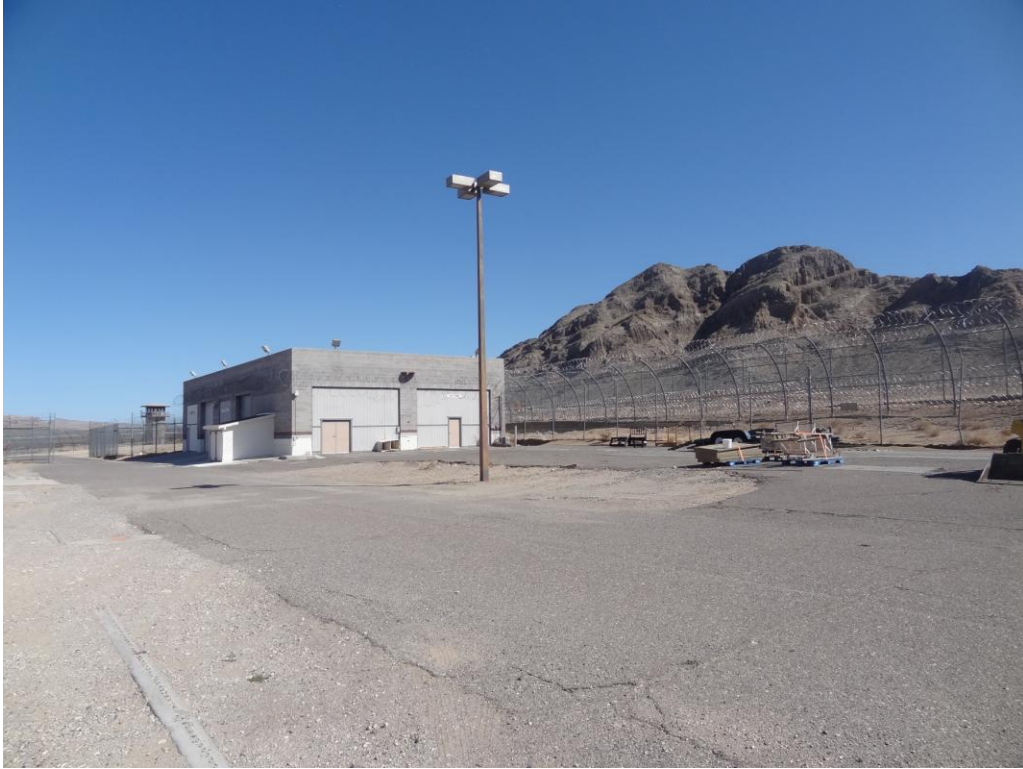
Southern Nevada Correctional Center Site - Site #9994
Description: AC paving in need of replacement.

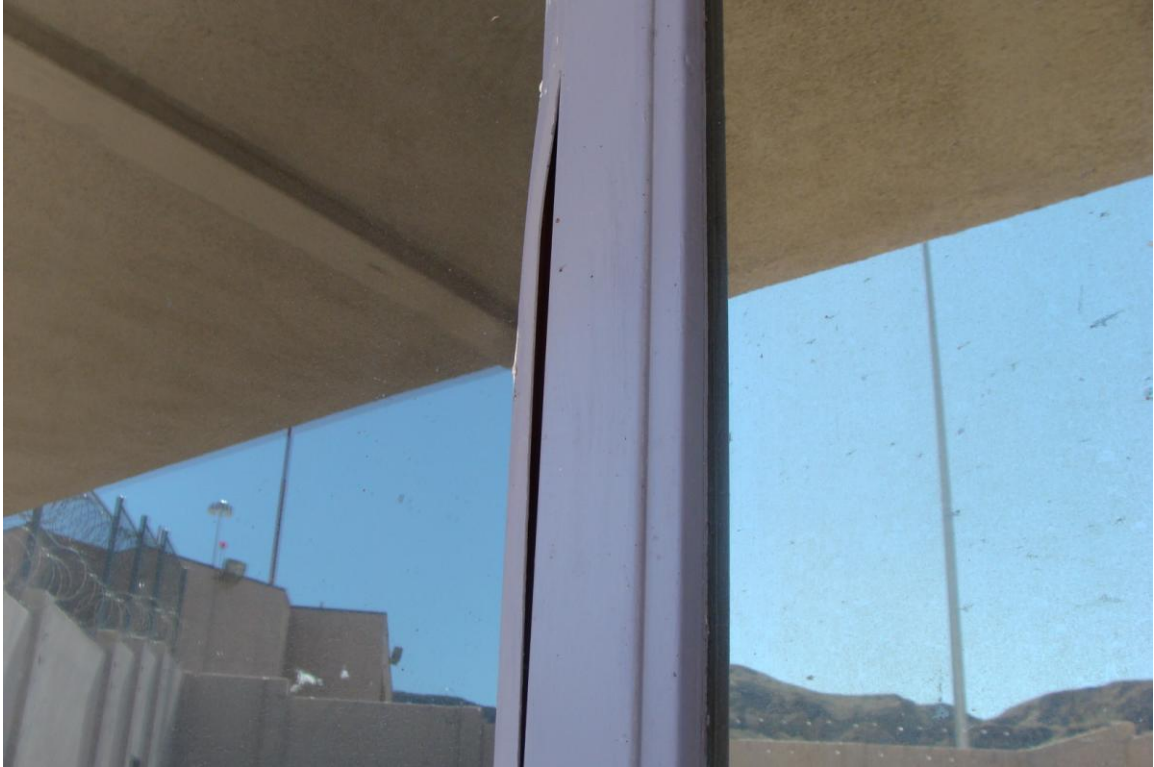
Administration / Visitation - Building #0176
Description: Damaged curtain window glazing stops.

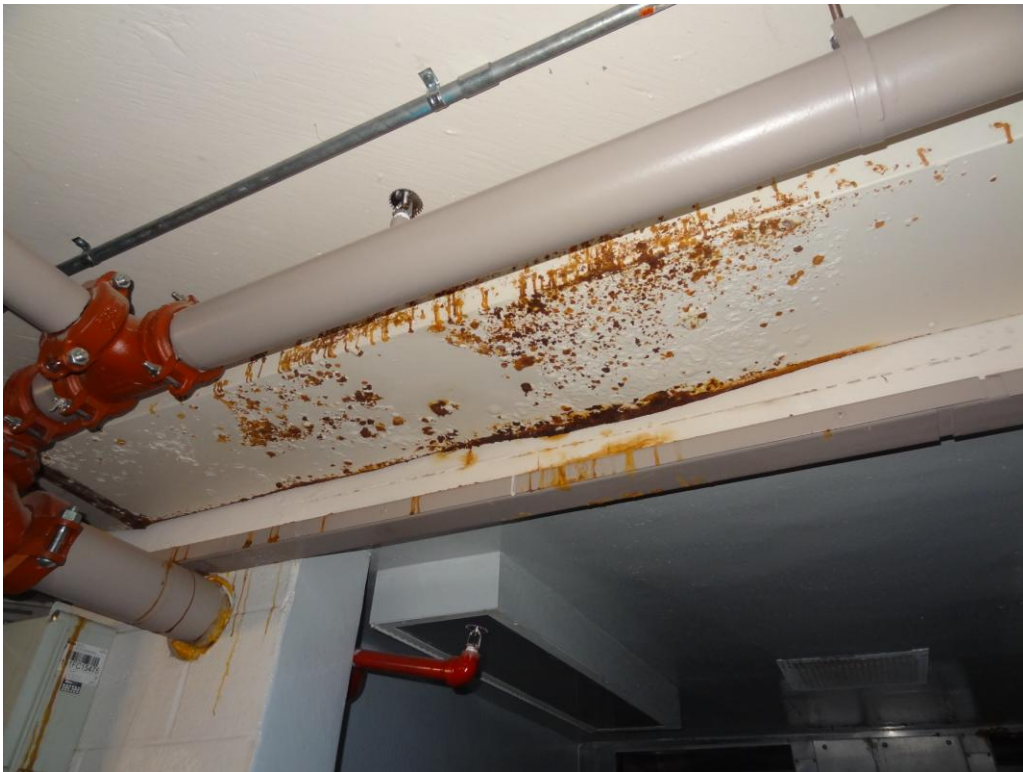
Housing Unit 1 - Building #0180
Description: Water damage from leaking pipes.

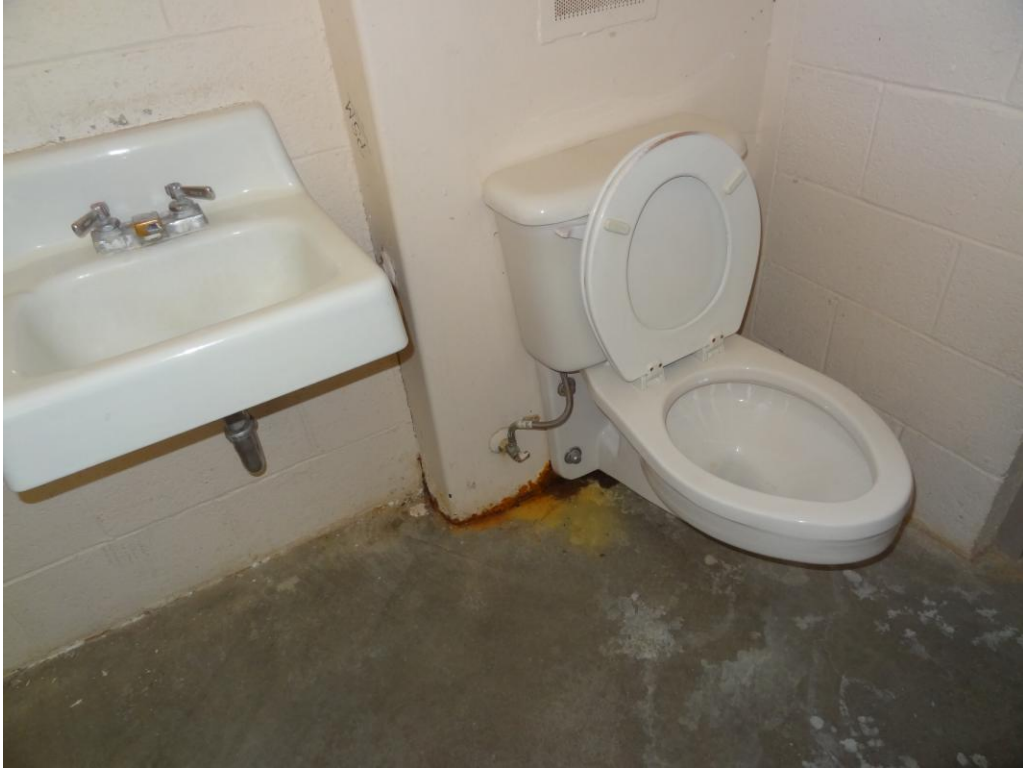
Housing Unit 1 - Building #0180
Description: Water damage from leaking pipes at cell fixtures.

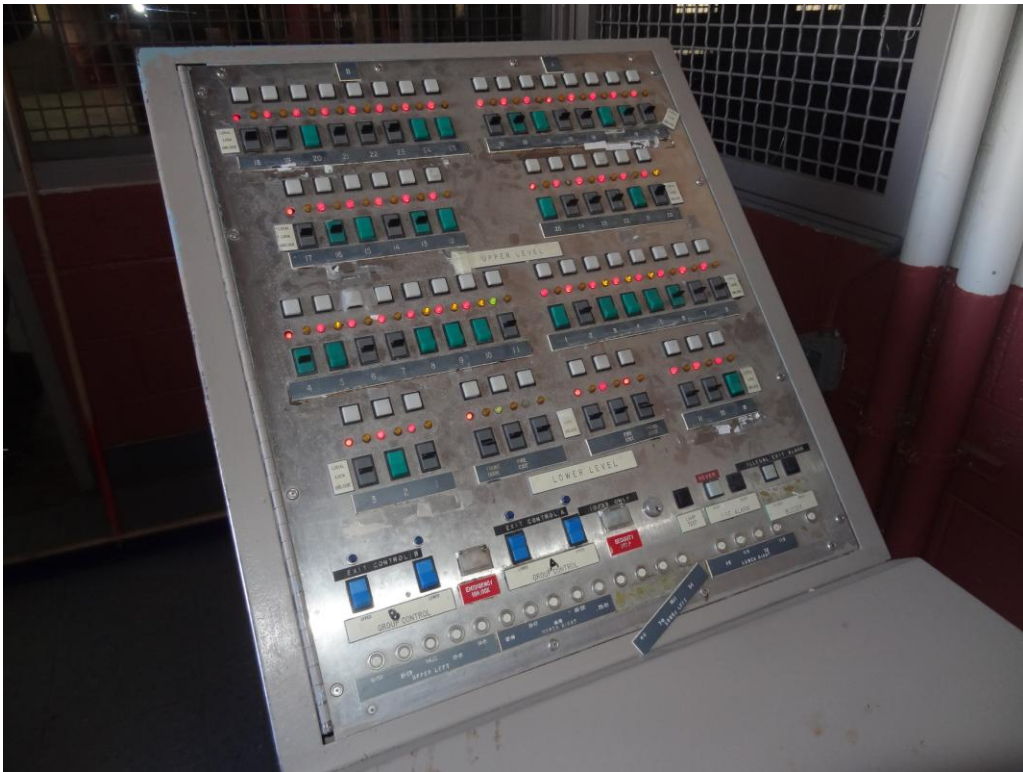
Housing Unit 1 - Building #0180
Description: Control panel in need of replacement.

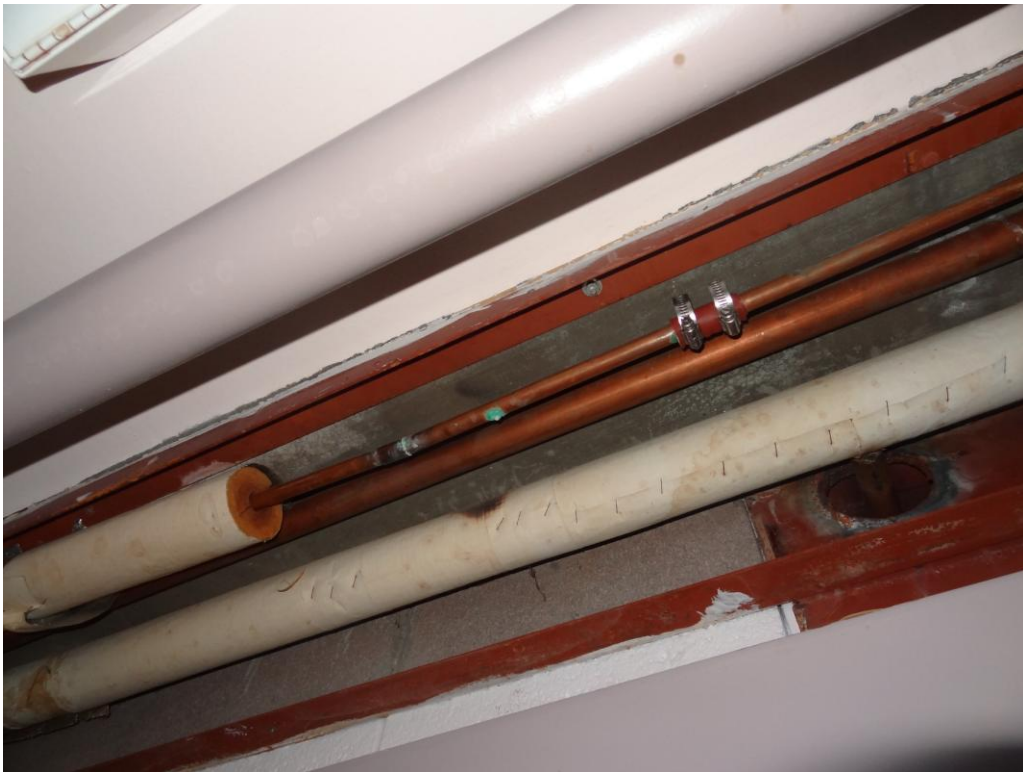
Housing Unit 3 - Building #0182
Description: Active and repaired pinhole leaks in copper plumbing.

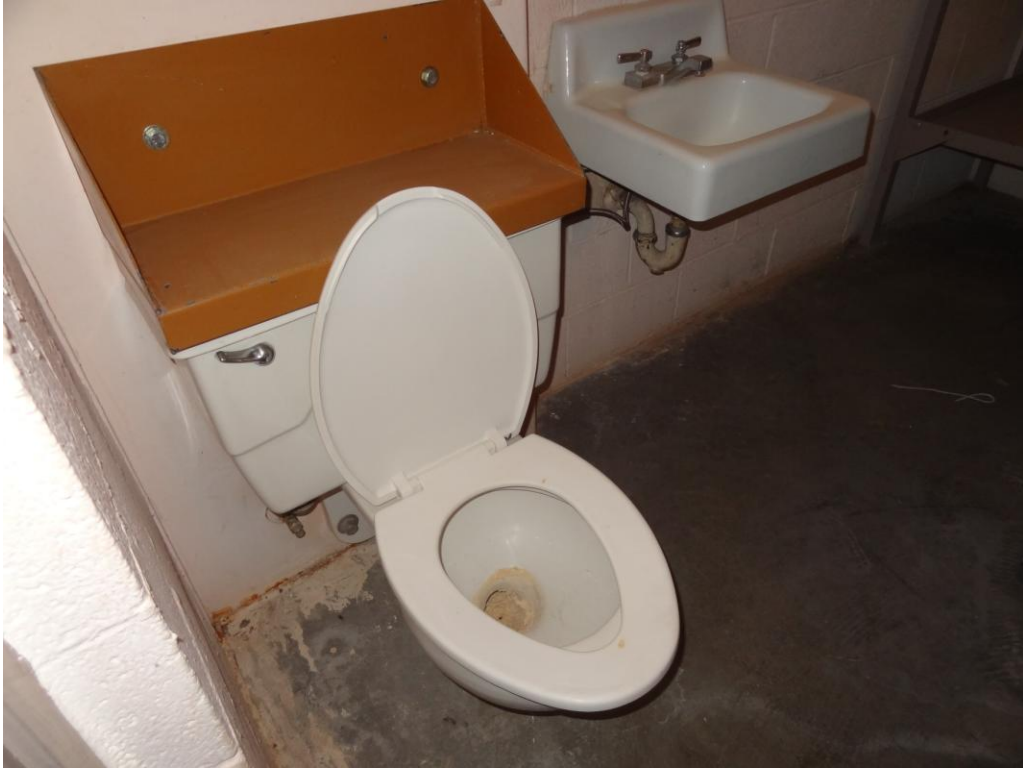
Housing Unit 3 - Building #0182
Description: Porcelain fixture in cell with dried out water closet.

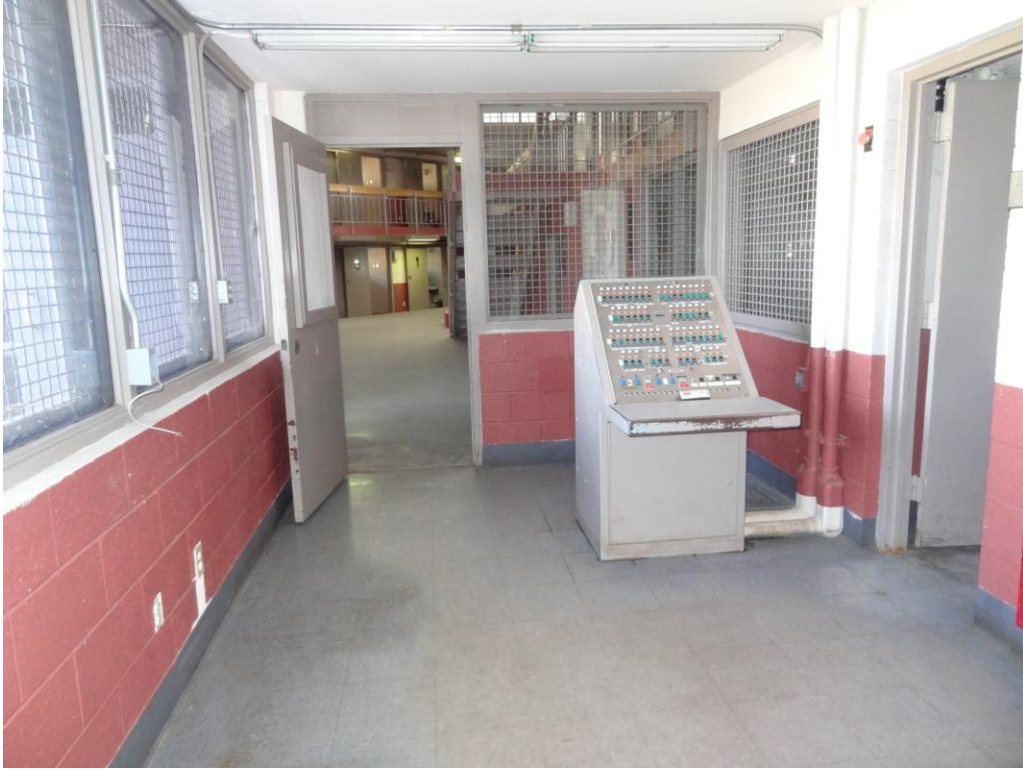
Housing Unit 4 - Building #0183
Description: Officer station with limited line of sight to cells.

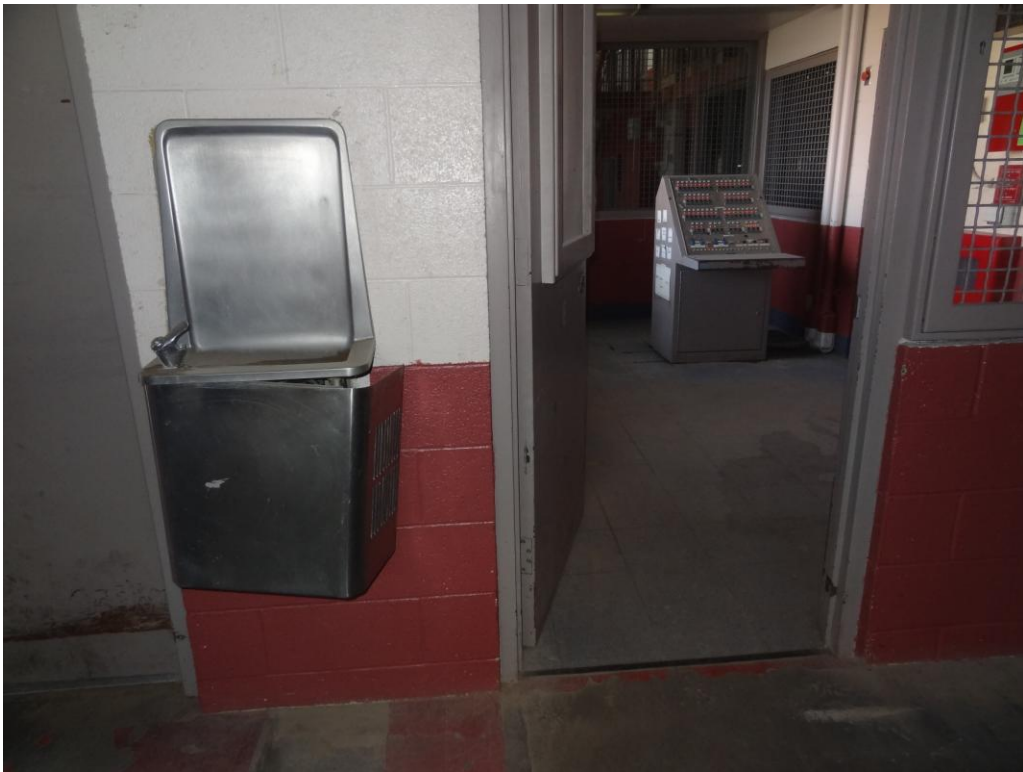
Housing Unit 5 - Building #0184
Description: Broken drinking fountain.

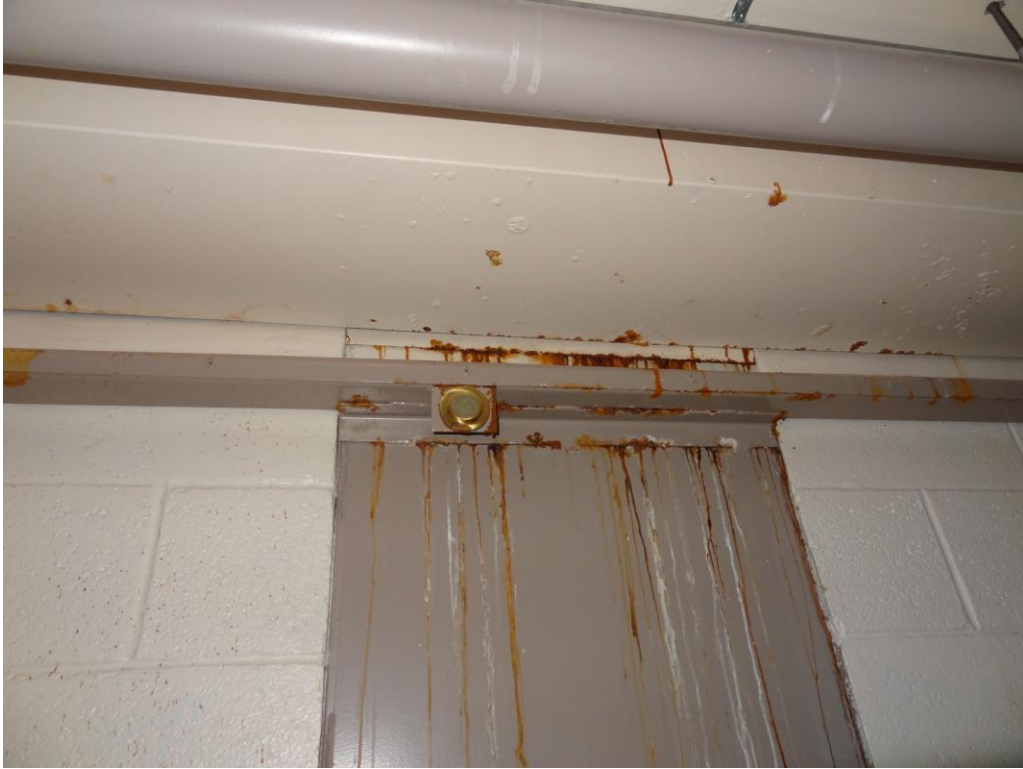
Housing Unit 5 - Building #0184
Description: Water damage from leaking pipes.

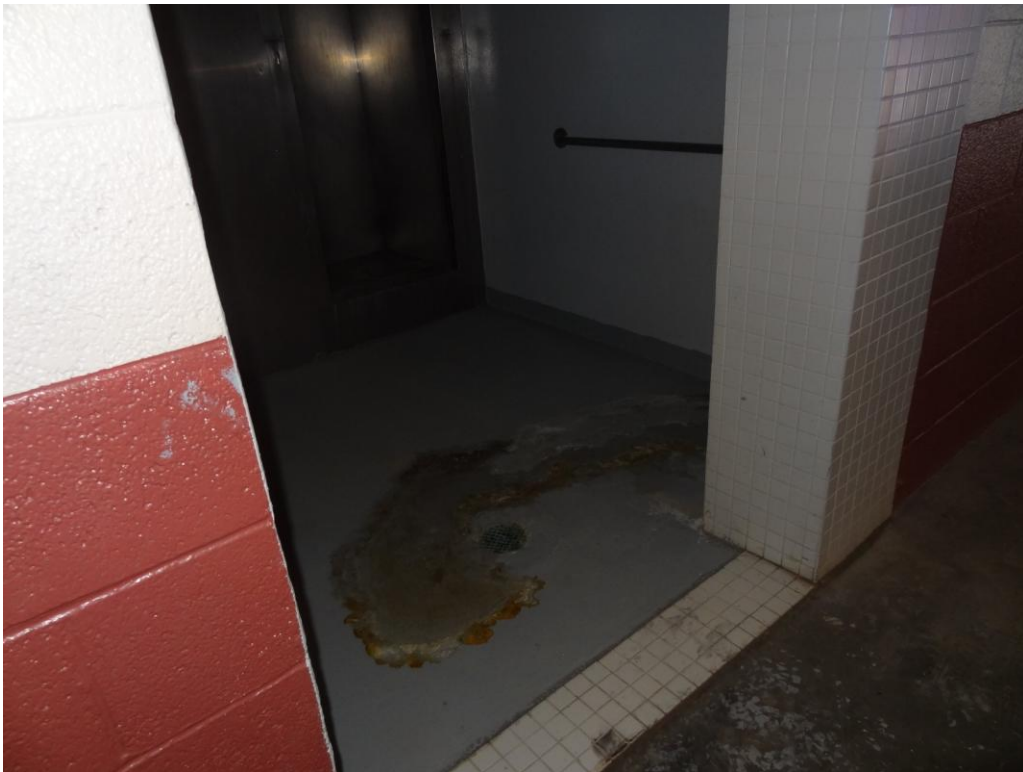
Housing Unit 6 - Building #0185
Description: Water damage in shower area.

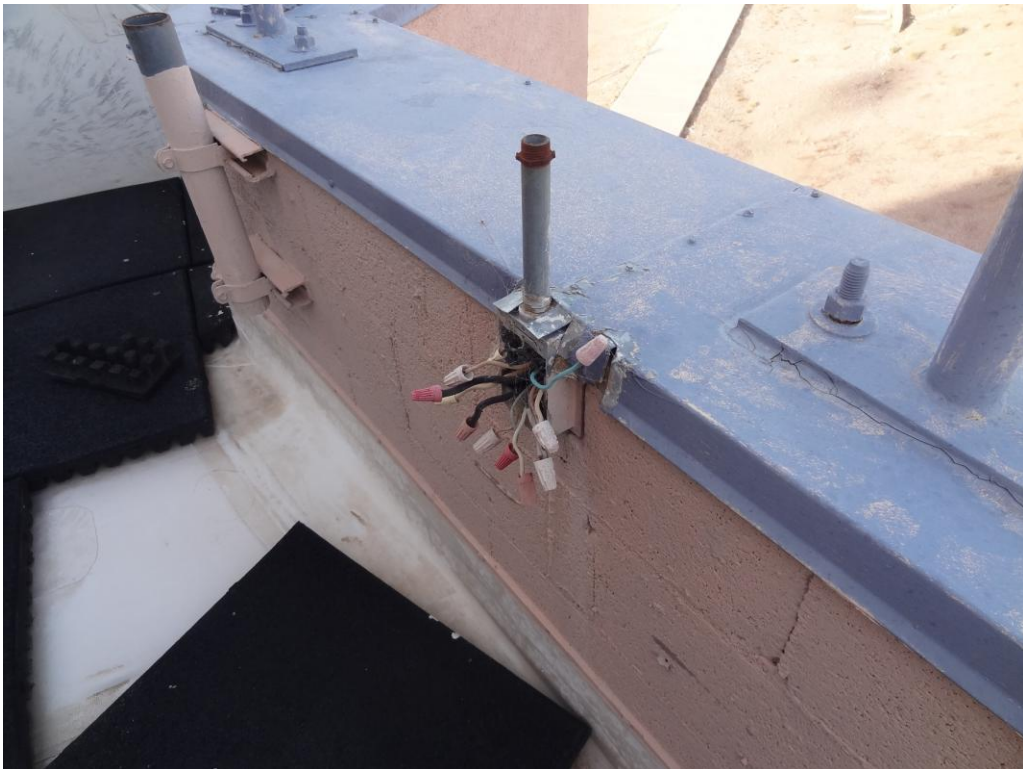
Recreation/ Gym - Building #0186
Description: Roof mounted electrical box in need of cover plate.

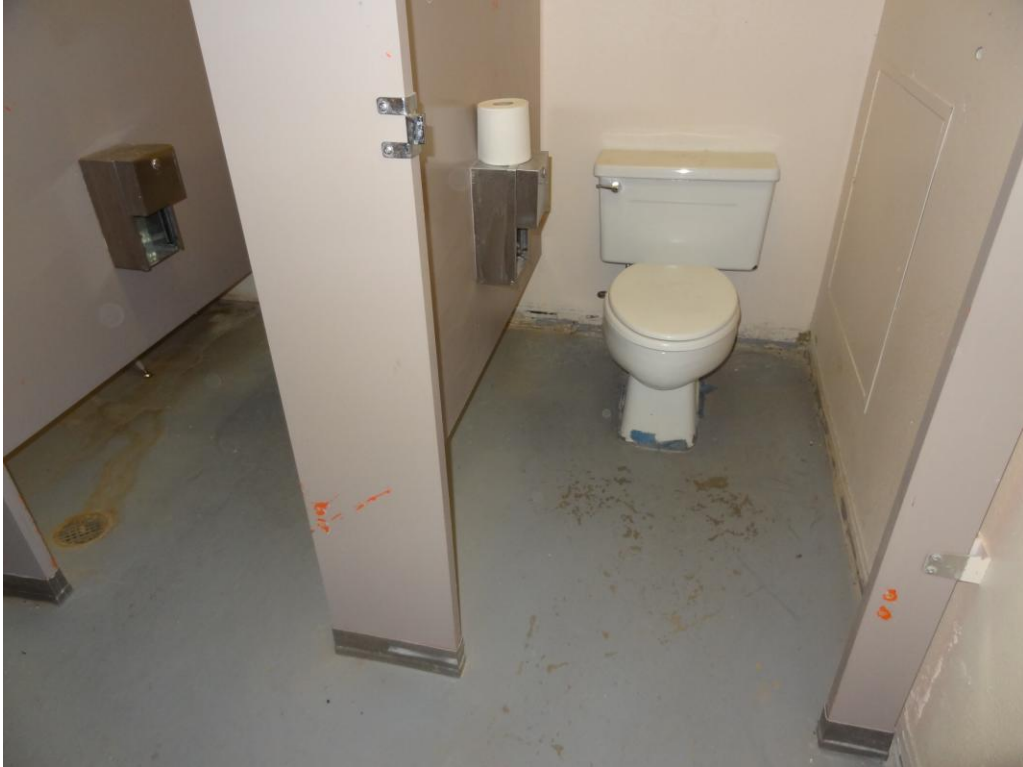
Recreation/ Gym - Building #0186
Description: Typical non-ADA restroom stall.

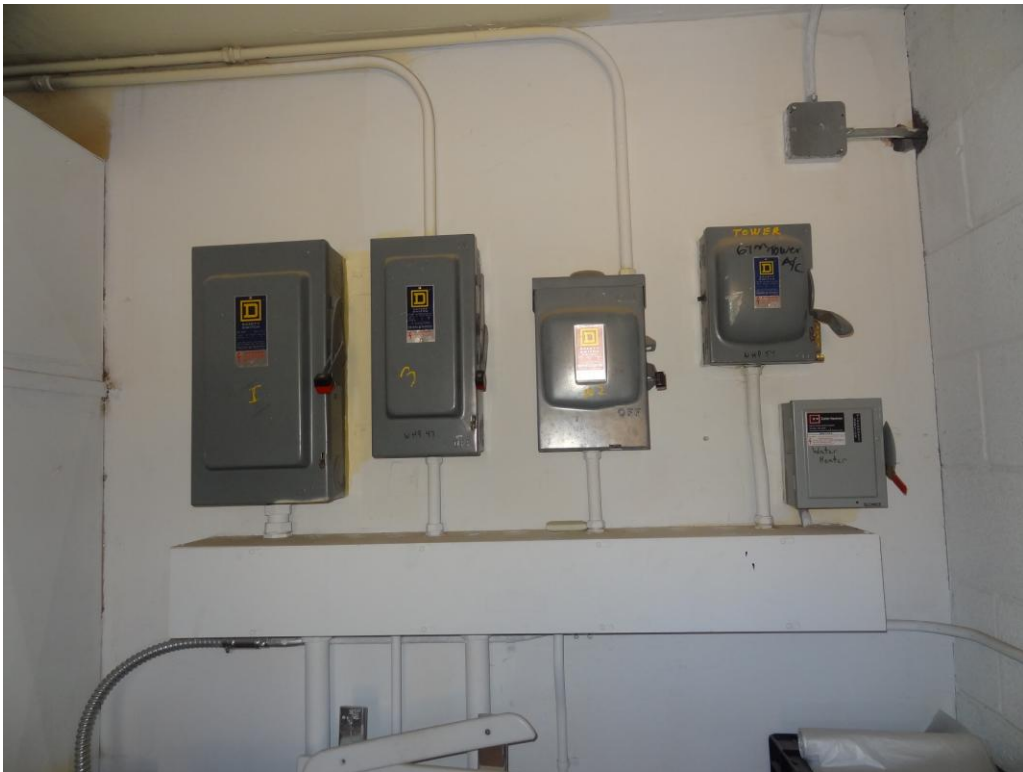
Recreation/ Gym - Building #0186
Description: Electrical equipment in need of replacement.

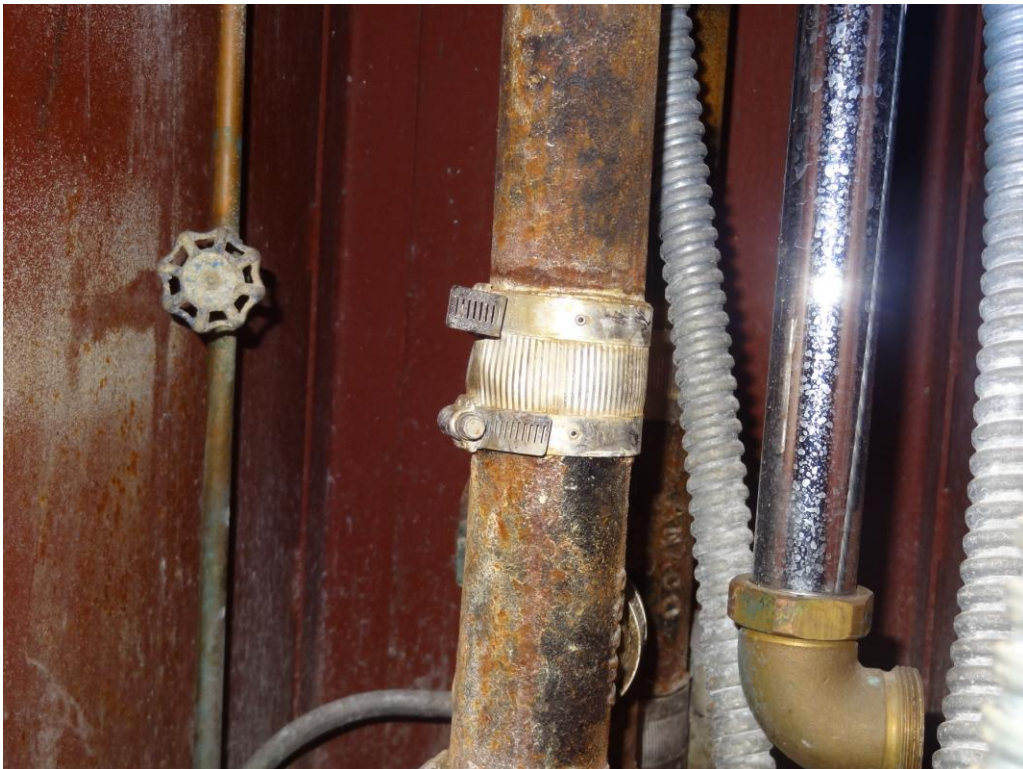
Housing Unit 7 - Building #0187
Description: Plumbing lines in need of replacement.

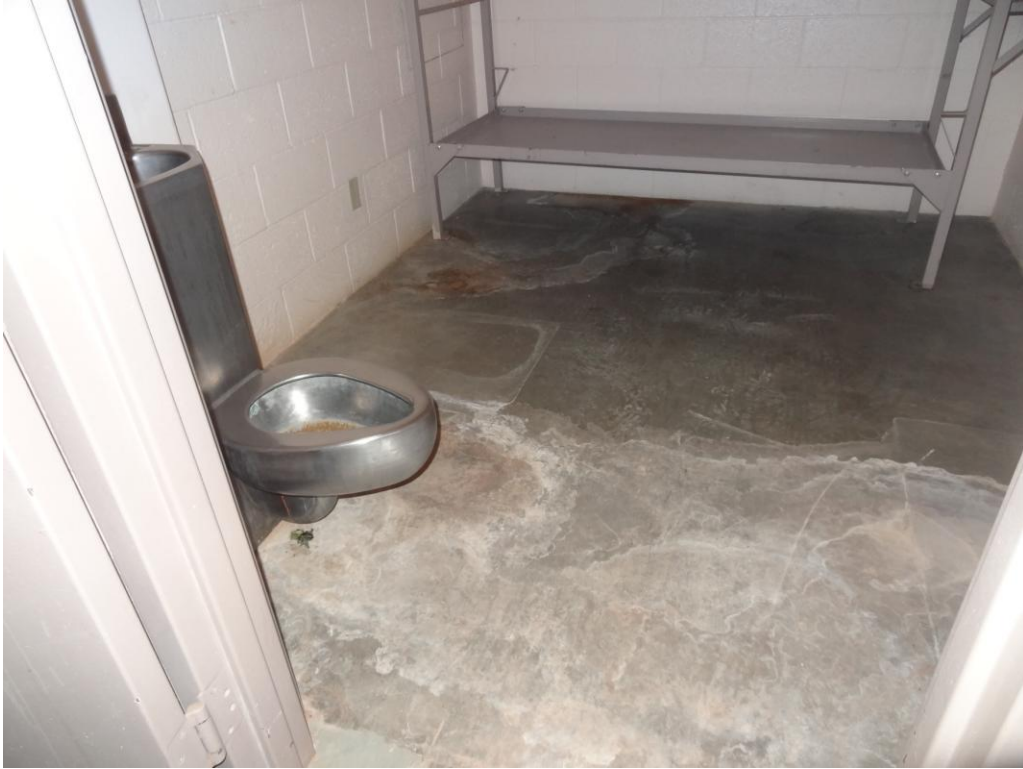
Housing Unit 7 - Building #0187
Description: Water damage from plumbing leaks.

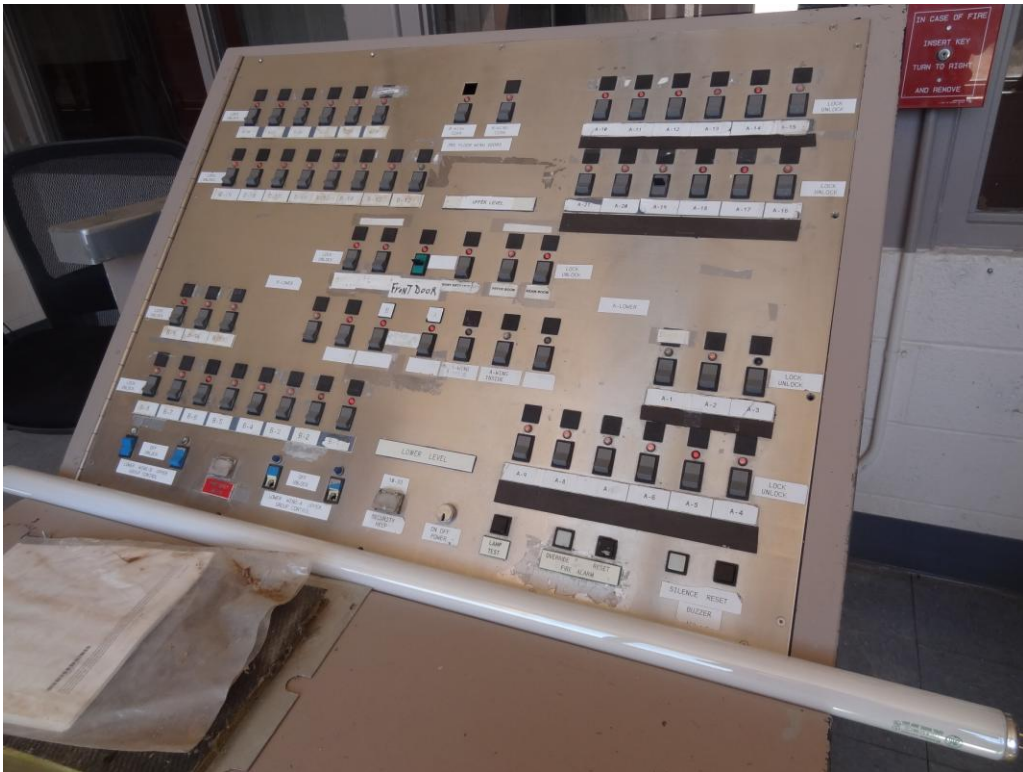
Housing Unit 7 - Building #0187
Description: Control panel in need of upgrade.

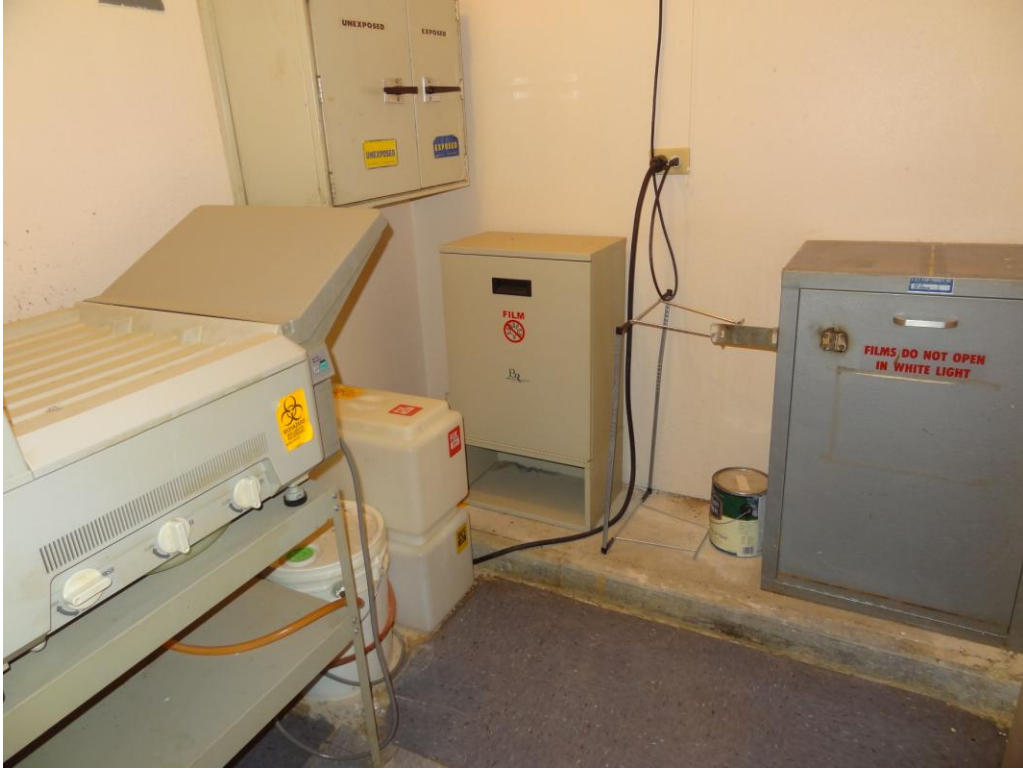
Medical Unit 8 - Building #0188
Description: Outdated medical equipment.

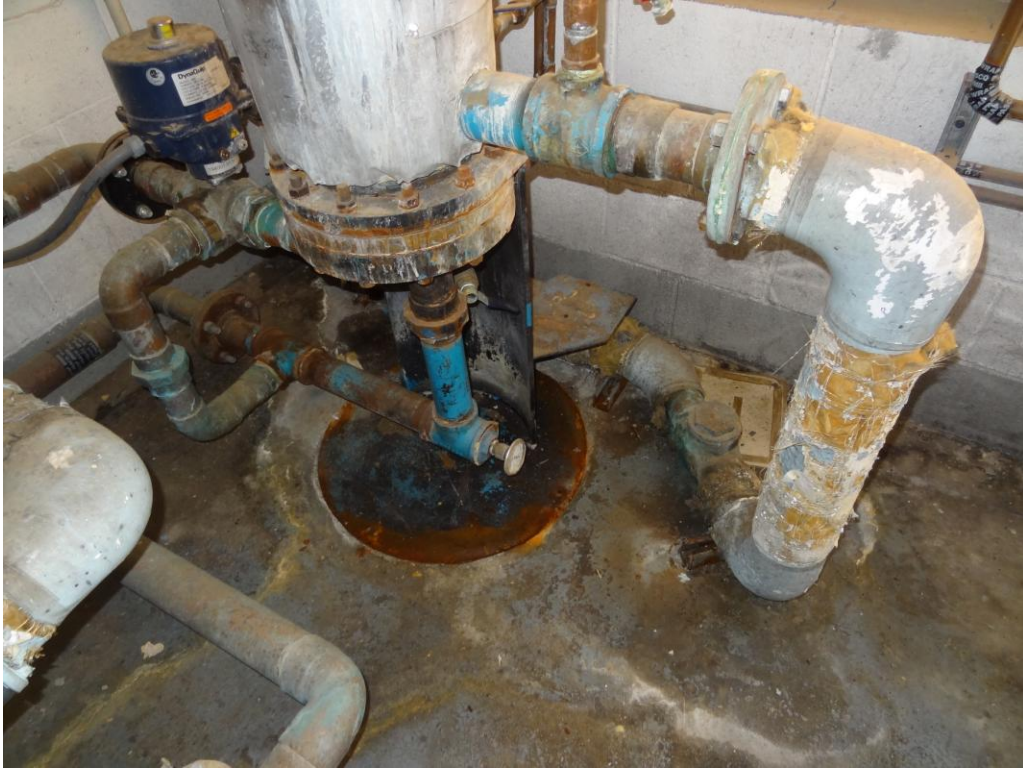
Culinary/ Dining/ Central Plant - Building #0190
Description: Central Plant equipment in need of replacement.

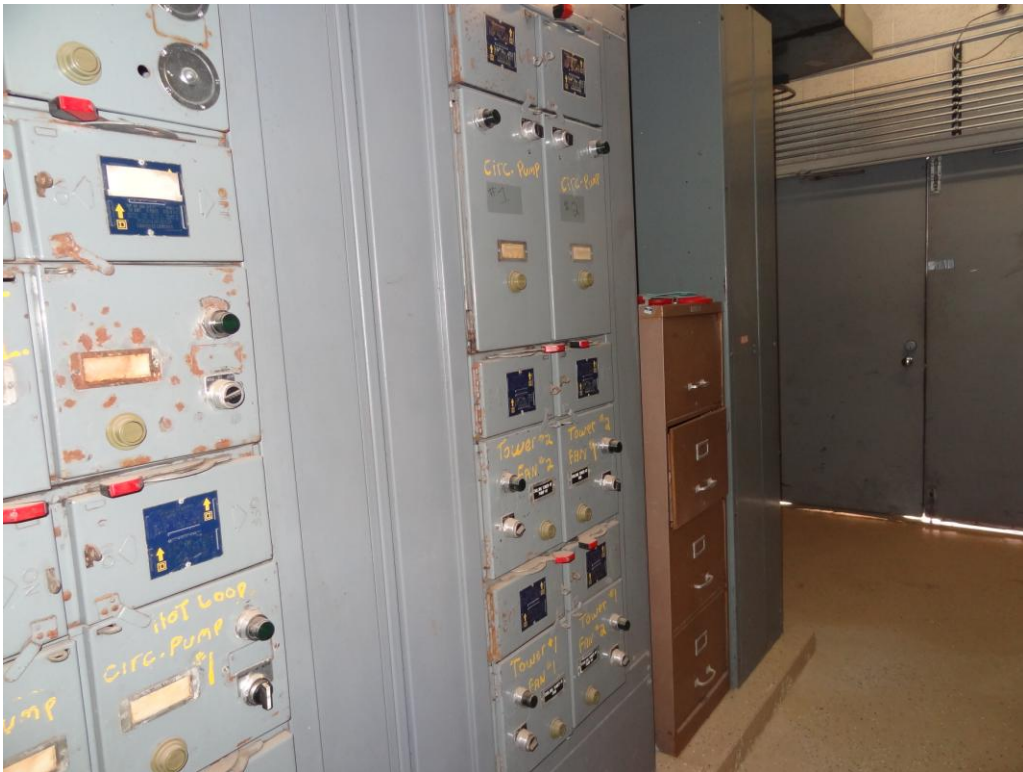
Culinary/ Dining/ Central Plant - Building #0190
Description: Electrical equipment in need of replacement.

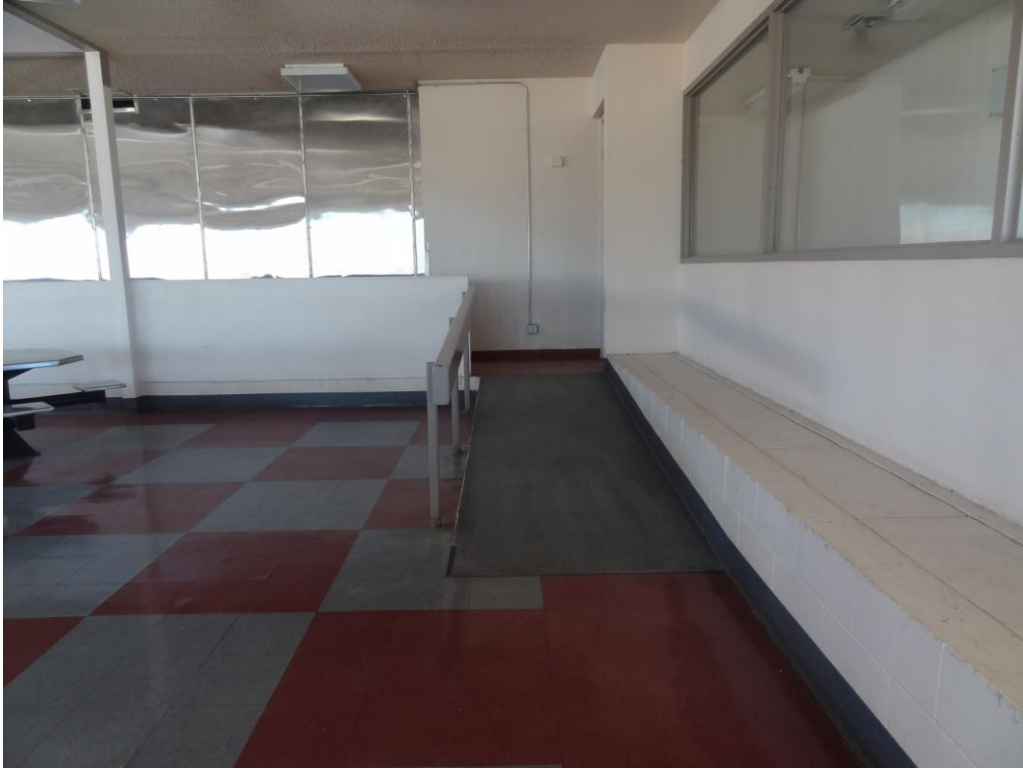
Culinary/ Dining/ Central Plant - Building #0190
Description: Non-ADA compliant ramp in dining.

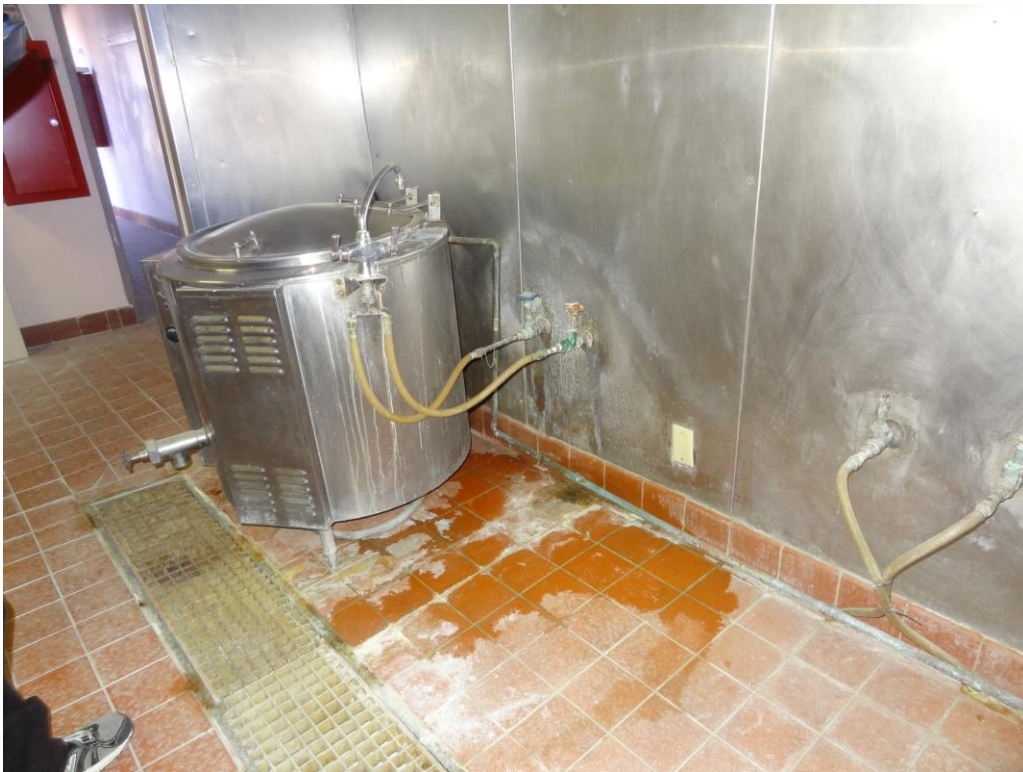
Culinary/ Dining/ Central Plant - Building #0190
Description: Damaged and missing cooking equipment.

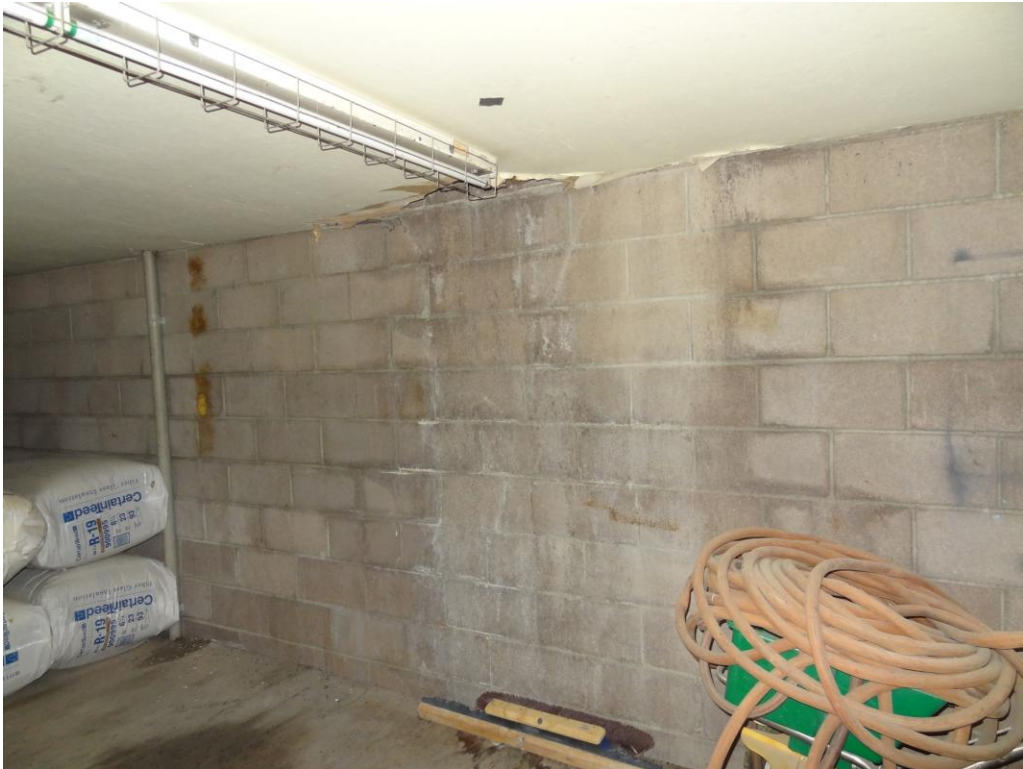
Auto Maintenance Shop/ Warehouse - Building #0192
Description: Interior of the building with water damage.

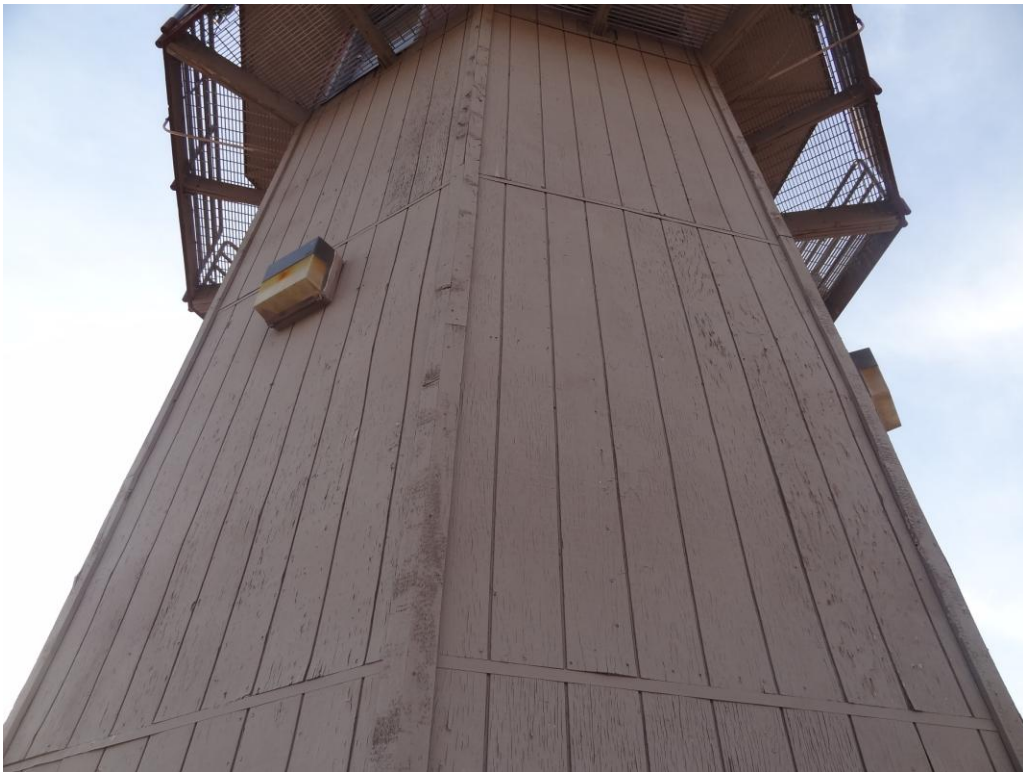
The Guard Tower 2 is a wood and steel framed structure with T1-11 siding, asphalt composition roof on a concrete slab-on-grade foundation. The building's interior contains a sink and a toilet for use by staff when occupied, painted gypsum board, windows and an observation deck. The tower is in poor shape and vacant.

Guard Tower 2 - Building #0195
Description: Exterior of the building.

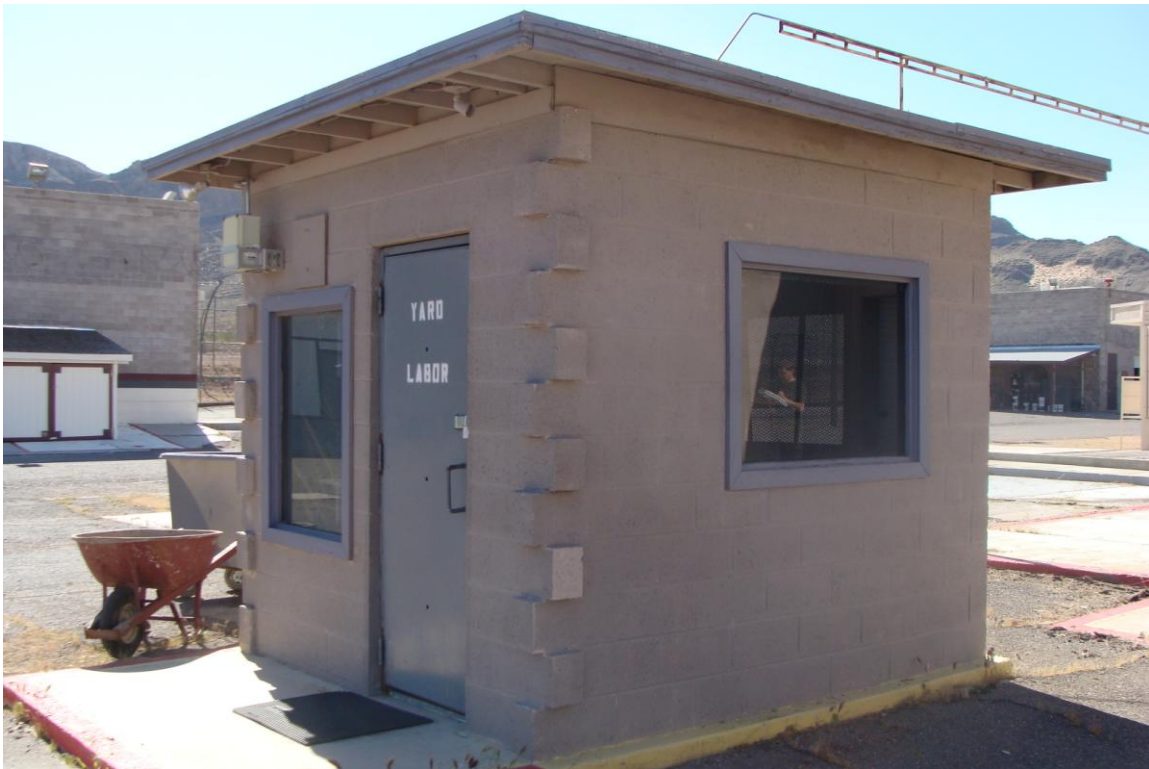
The Sally Port building is a painted concrete masonry unit structure with a single-ply membrane roof on a concrete slab-on-grade foundation. The building is unoccupied and no longer is being used. It is in poor shape with damaged doors, windows and a void where the HVAC packaged unit was once located.

Sally Port - Building #2567
Description: Exterior of the building.
